(NASA-CR-170882) VERIFICATION OF THE SBB
MOTOR CASE PIN RETAINER BAND TIPS (Lockheed
Missiles and Space Co.) 42 p HC A03/MF A01
CSCL 21H

VERIFICATION OF THE SRB.
MOTOR CASE PIN RETAINER
BAND TPS

March 1980

Contract NAS8-32982

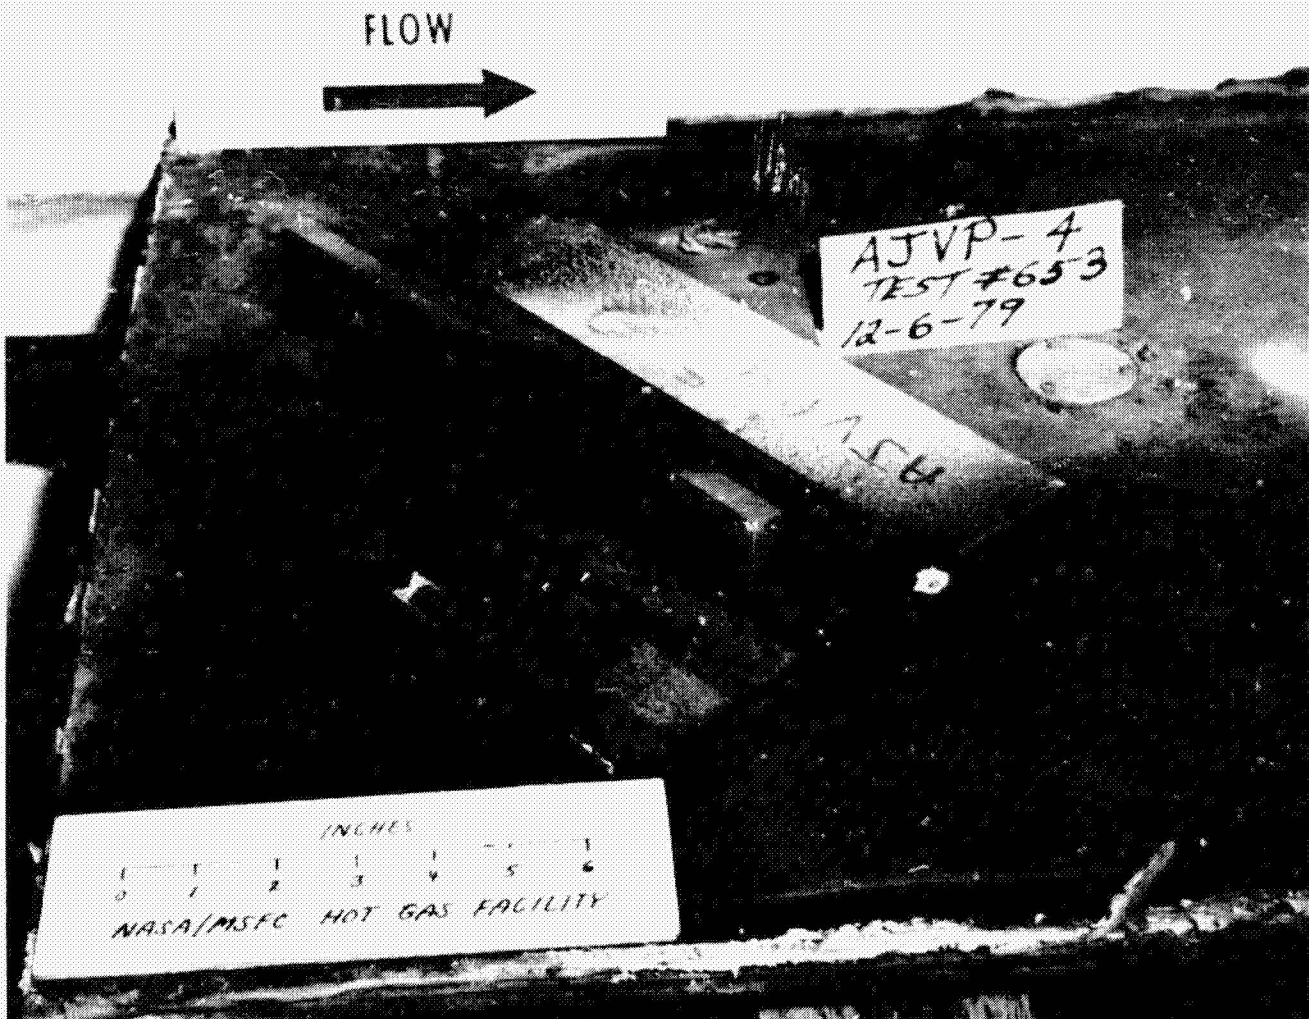
Fig. 5 - Post-Test Picture of the Kick Ring Area Pin Retainer Band Cork TPS
Which Was Closed Out with K5NA

A remedy for the above situation was to protect the downstream cork band edge by closing it out with a trowelable material such as K5NA. The test was repeated with the area between the cork band and the "Zee" section uniformly covered with K5NA of thickness equal to that of cork (see pre-test picture in Fig. 4). The model was run longer than required, a full 60 seconds, and as expected it performed well. The maximum steel band temperature was 406 F. A post-test picture of the model is shown in Fig. 5.

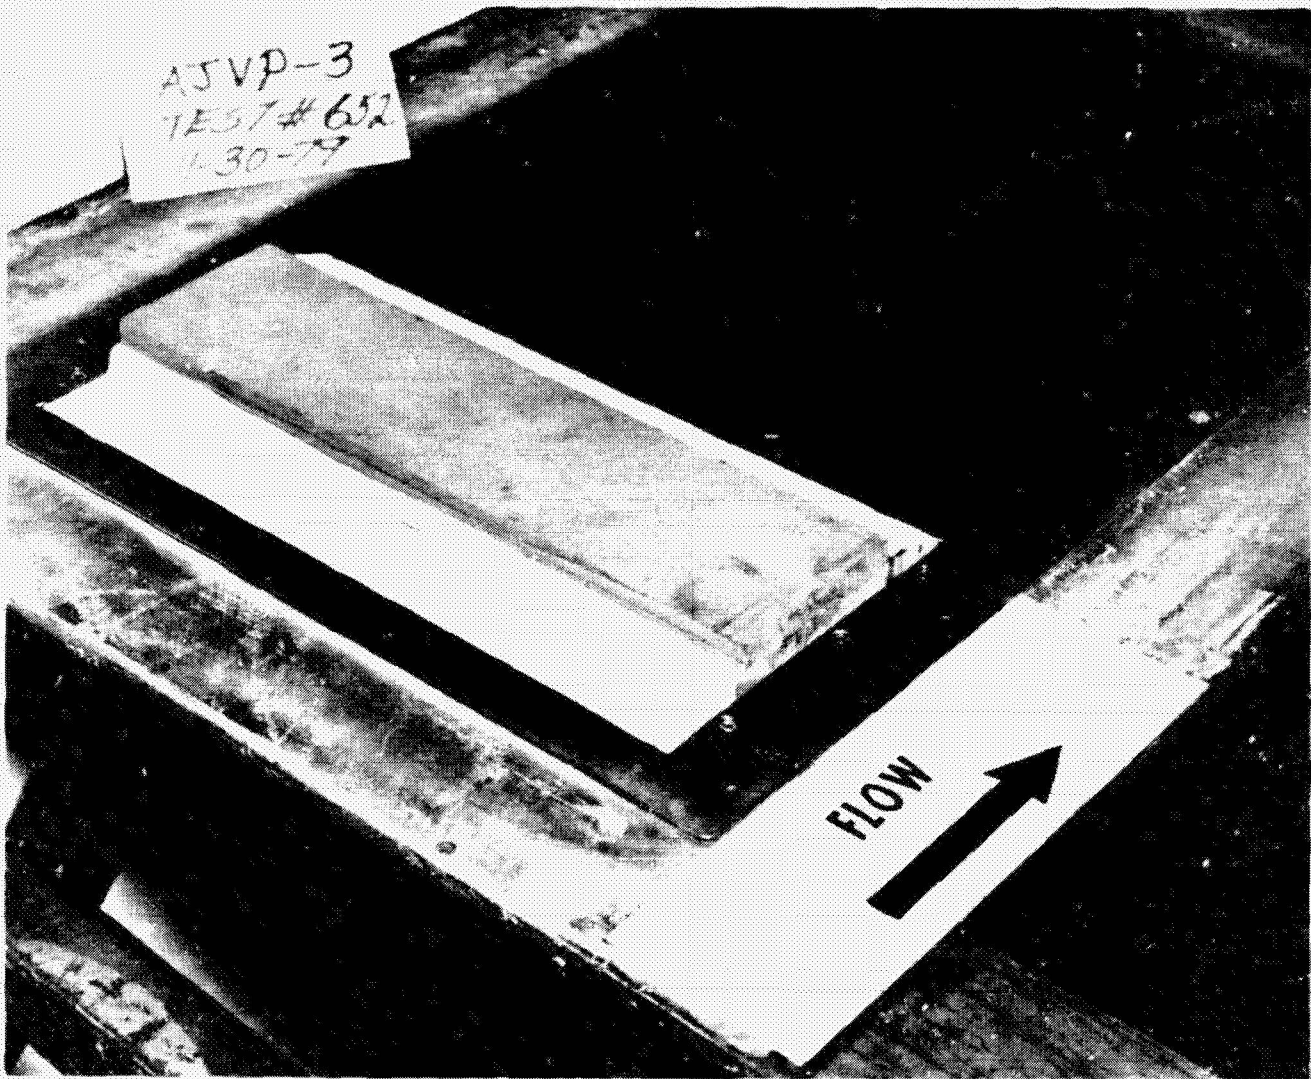
Fig. 7 - Pretest Photograph of the Unperturbed Area Pin Retainer Band TPS Model in Hot Gas Facility

The model was run for the duration of 60 seconds as required to obtain the full heat load. The pre- and post-test pictures of this test are shown in Figs. 7 and 8. The leading edge of the cork is seen to have receded back but there was no appreciable surface recession. There was little or no rise in band temperature.

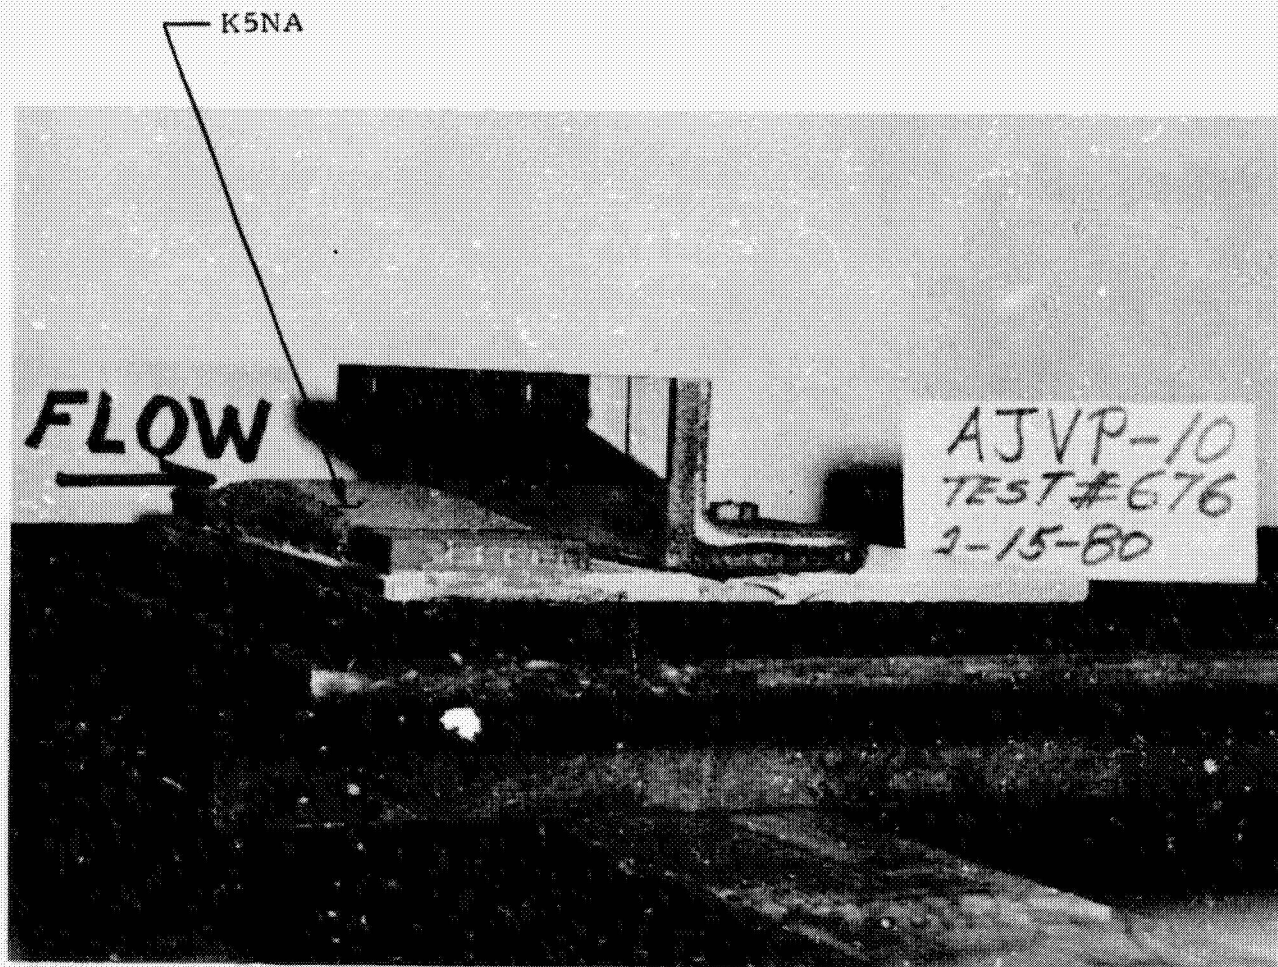
Fig. 21 - Pin Retainer Band TPS Model in the Area Where the Band is "Crimped" and Closed Out with K5NA

Another area of interest on the pin retainer bands is the point where the two ends of the band are crimped together after tensioning the band. The cork TPS is stopped short on either side of the crimp and the region over the band is closed out by a smooth hump (maximum height in center approximately 0.62 in.) of K5NA closeout material. A test model simulating this configuration was made up for the kick ring area pin retainer band model and tested in the

Hot Gas Facility. A picture of the model is shown in Fig. 21. The test environment for this region are:

The model was run for a duration of 17.4 sec to obtain the total heat load of 608 Btu/ft². The model performed very well in protecting the metal band. There was little or no rise in the band temperature during the test.

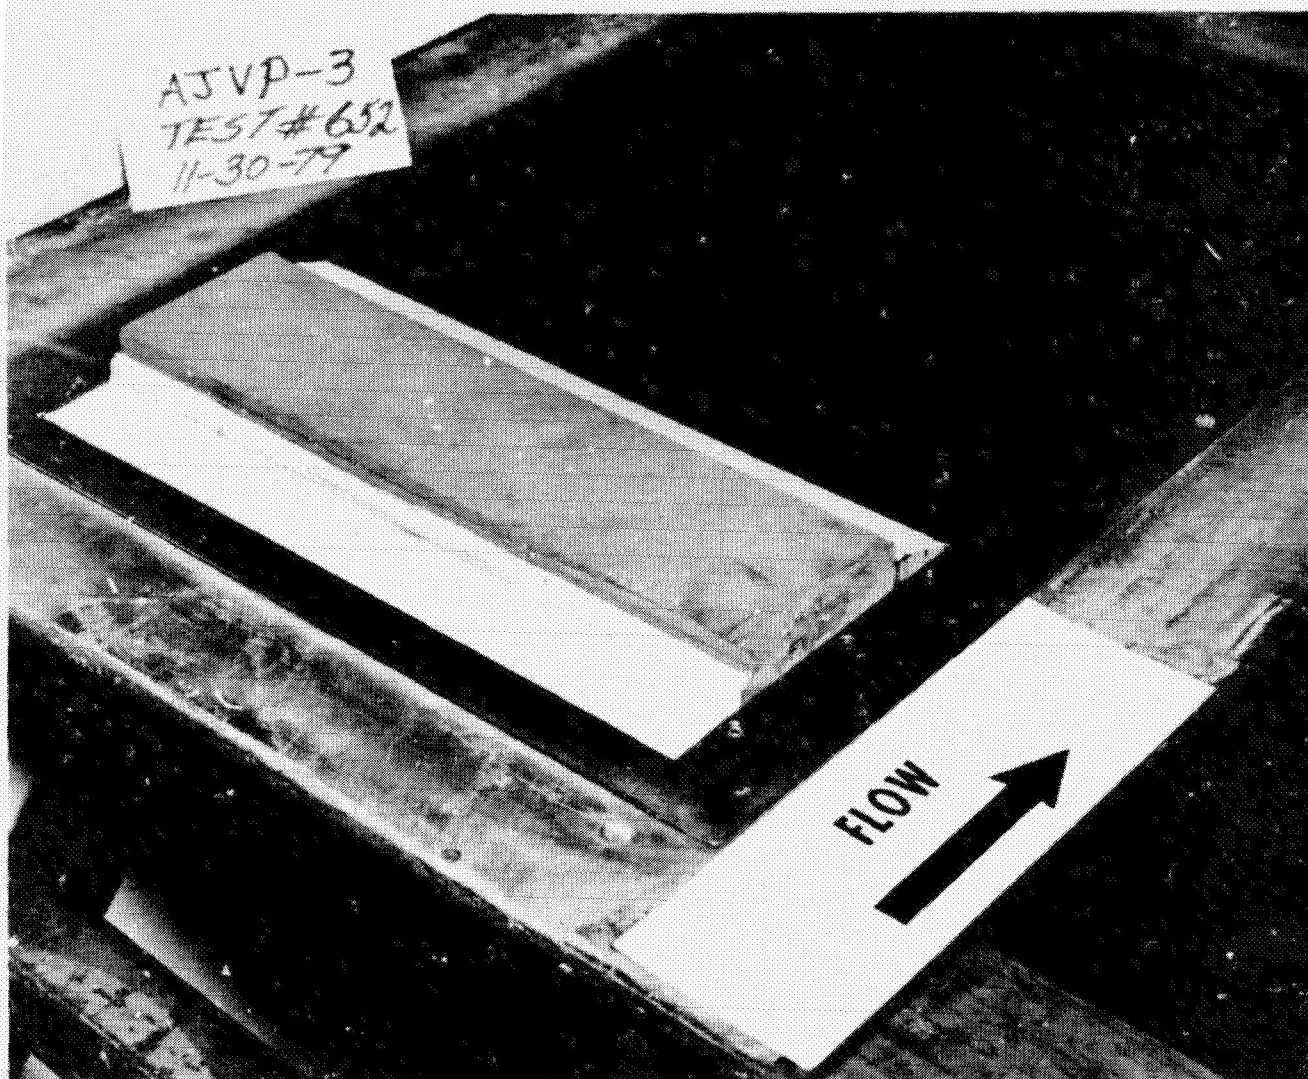
Model Description: Unperturbed area clevis joint pin retainer band model with .375 in. cork over steel band

- Band Temperature - T_{start} = 27 F. T_{end} = 130 F
- TPS Thickness | - Pretest = .375 in.
Over Band | Post-Test = .350 in.
- The LE of cork TPS receded back about .125 in; no appreciable surface recession

A good design margin available in this configuration since plenty of cork left after test.

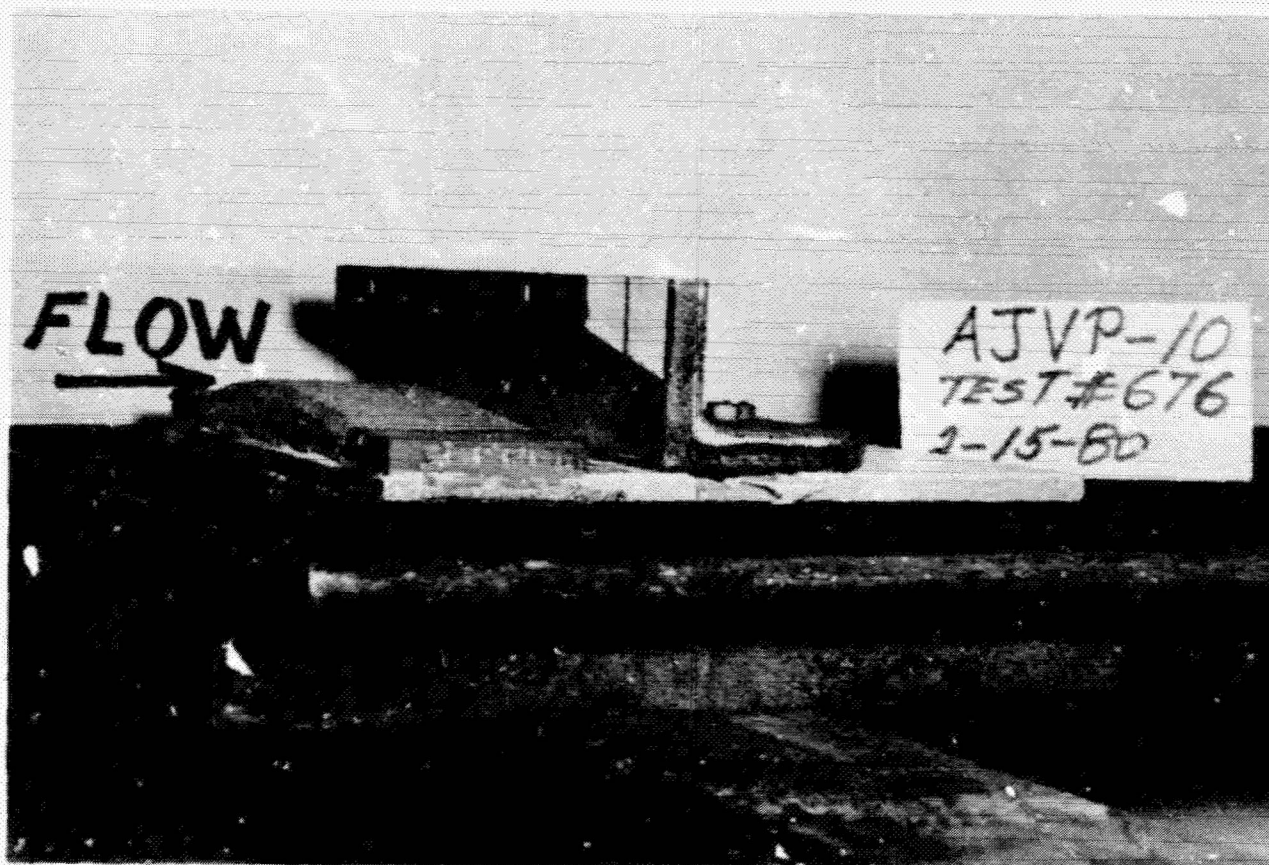
Model Description: 2.5 in. KR protuberance in front of .375 in. cork TPS over the steel pin retainer band that is crimped within a 6 in. wide gap in the cork band. The gap is closed out with K5NA

- Band Temperature - T_{start} = 57 F, T_{end} = 59 F
- K5NA Thickness | - Pretest = .62 in.
Over Band | - Post Test = .60 in.

Conclusions: The run time of 17.4 sec was determined based on the initial measured heat flux of 35 Btu/ft²-sec. The new \dot{q} of 29.4 rendered a shortage of 16%. Since hardly any degradation of K5NA obtained, the configuration as tested is completely acceptable.
